Property Condition Report

123 Main St
Bellevue, NE 68005

Prepared for: Mary Smith

Prepared by: It's Your Home Inspection, LLC
9605 S 22nd Ave
Bellevue, NE 68147
402-885-1498
ASHI Member ID #261062

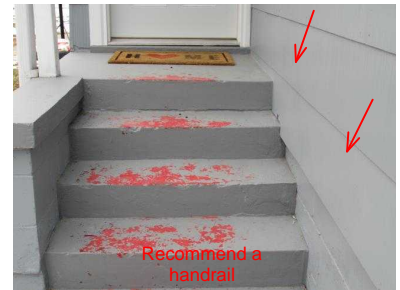
1. Driveway: Concrete
2. Walks: Concrete
3. Steps/Stoops: Concrete - Missing handrail. This is a safety concern. Recommend a qualified contractor evaluate further and repair as needed.

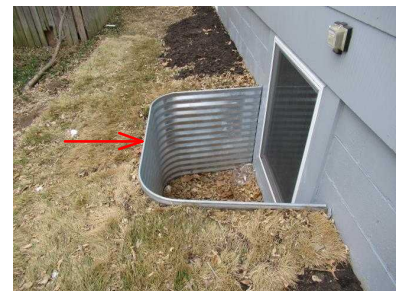
6. Window Wells: Not covered - Window well is not covered. Uncovered window wells can hold debris and moisture at the foundation wall. Recommend covers.

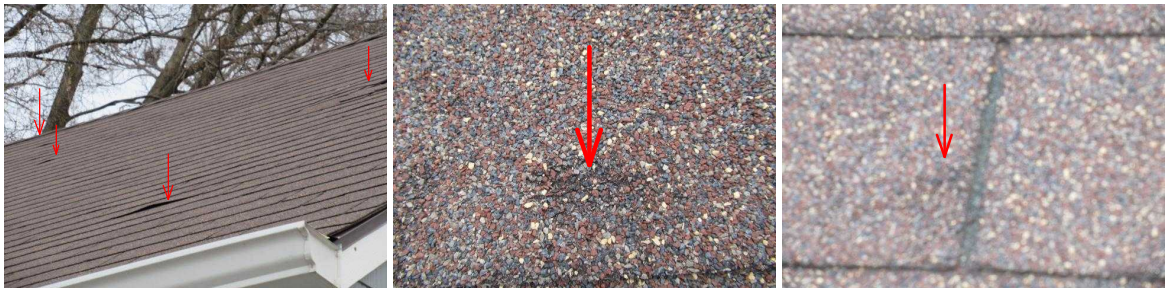
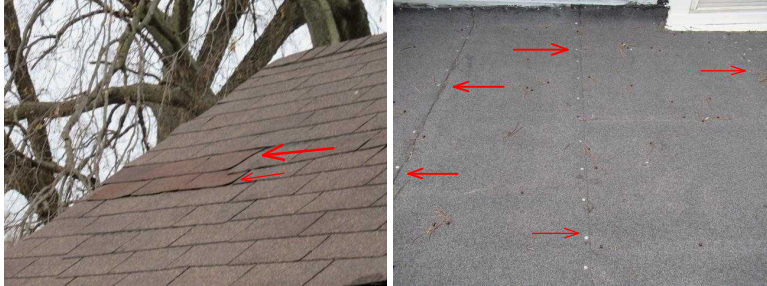
- Method of Inspection: Ladder at eaves
- Material: Asphalt shingle, Rolled roof material - This is a gable roof with a flat roof over the added attached garage. The gable roof coverings have slight shingle lift with some hail strikes and previous repairs to the coverings. The flat rolled roofing material nail heads are exposed without a sealant. Recommend a qualified roofing professional evaluate further and repair as needed.

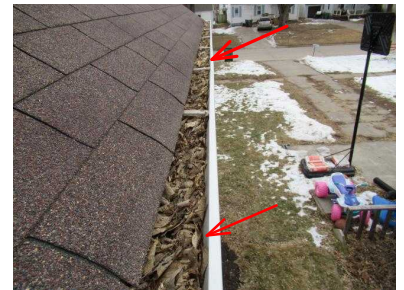
- 3. Type: Gable, Flat
- 4. Approximate Age: Around 10 yrs
- 5. Flashing: Aluminum or metal
- 6. Plumbing Vents: Cast Iron
- 7. Electrical Mast: Surface mount
- 8. Gutters: Aluminum or metal - Gutters are full of debris.
Recommend cleaning as part of regular maintenance.

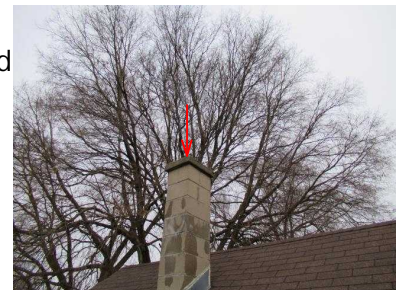
- 9. Downspouts: Aluminum or metal
 - 10. Leader/Extension: Aluminum or metal
- Center of the Home Chimney _____
- 11. Chimney: Block
 - 12. Flue/Flue Cap: Missing - Chimney cap is missing. Recommend installation. Recommend a qualified contractor evaluate further and repair as needed.

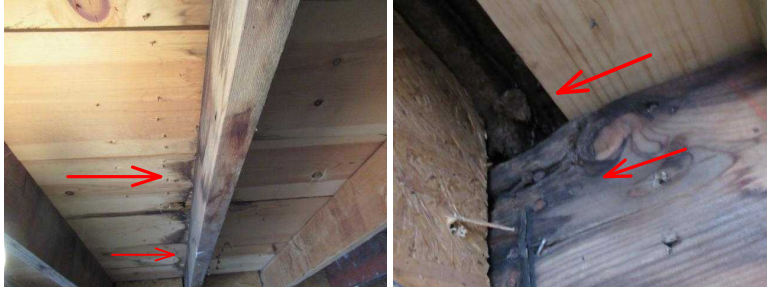
1. Type of Structure: Attached Car Spaces: 1
2. Garage Doors: Insulated aluminum or metal
3. Door Operation: Mechanized
4. Door Opener: Lift Master
5. Ceiling: Exposed framing - The ceiling has areas of previous water staining and rot from water intrusion at the flat roof. These areas tested dry today but there are concerns at the roof coverings. This is an FYI.

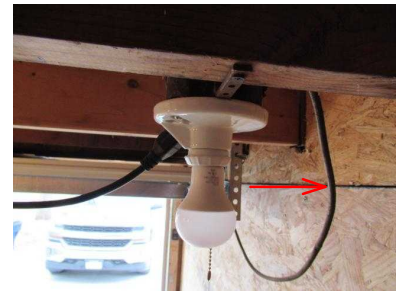
6. Walls: OSB and Block
7. Floor/Foundation: Poured concrete
8. Electrical: 110 VAC - Exposed run of Romex for the light fixture. Recommend a licensed electrician evaluate further and repair as needed.

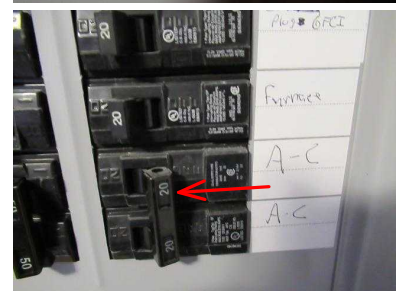
10. Breakers: Copper - The breaker for the A/C unit is in the off position. This is an FYI.

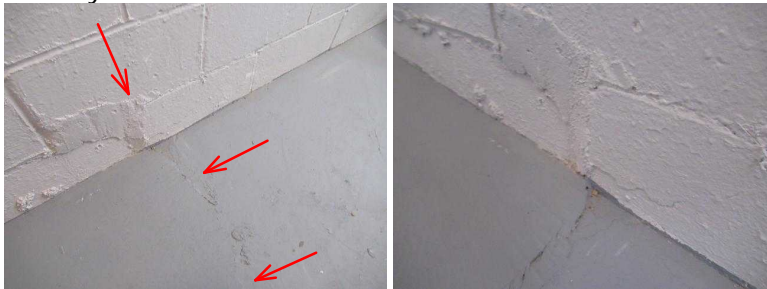
- Structure Type: Wood frame
- Foundation: Block - There is some settlement with displacement at the south block wall in the utility room and cracks at the concrete floor. I believe this is from previous water intrusion and probably is the reason for the recently added backfill along the south exterior wall. Recommend the buyer monitor this area and add additional backfill if needed.

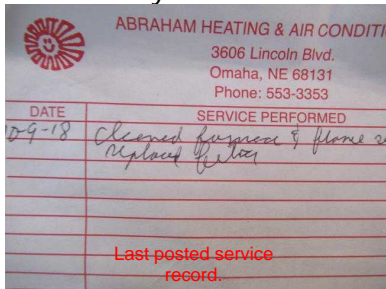
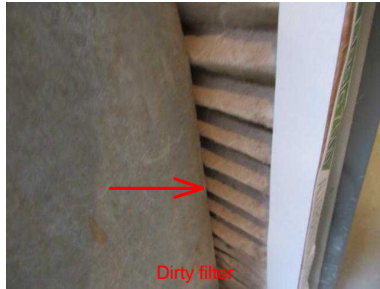
1. Heating System Operation: Functioning - The furnace did not have current posted service records and has a dirty filter. Recommend a qualified HVAC company service, clean and evaluate the HVAC system.

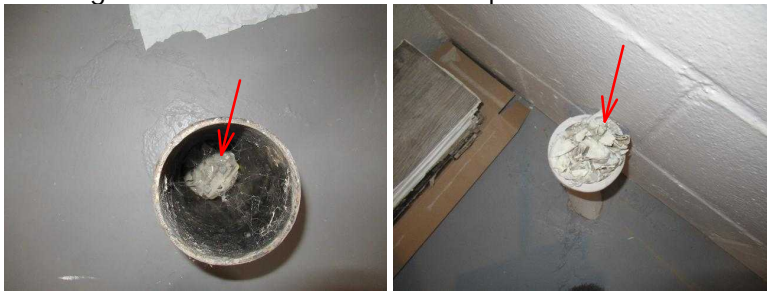
- 3. Water Lines: Copper
- 4. Drain Pipes: Cast iron - There is a rough-in for a toilet and sink in the basement north east corner. The waste lines have been filled with paper materials to block sewer gases from coming back into the home. I recommend that these lines are capped off the proper way to keep out sewer gases. Recommend a licensed plumber evaluate further and repair as needed.

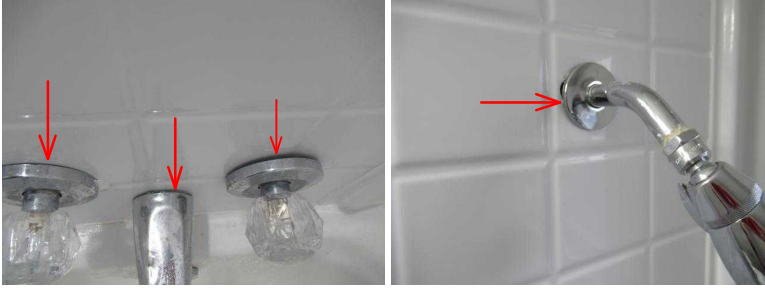
10. Tub/Surround: Fiberglass tub and fiberglass surround - Main bathroom showerhead, handles and tub spout have gaps at the front wall. Recommend sealing/caulking at these areas to control any water from getting behind the surround.

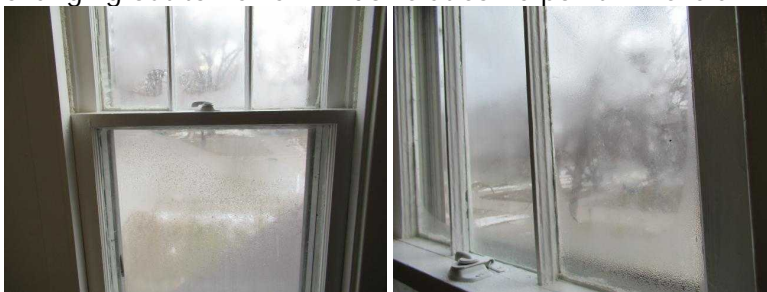
1. Ceiling: Drywall
2. Walls: Drywall
3. Floor: Wood and Carpet
4. Windows: Wood slider - Some of the older windows are not efficient and moisture/condensation is getting in between the window and the storm windows. Recommend sealing window gaps or changing out to newer windows at some point. This is an FYI.

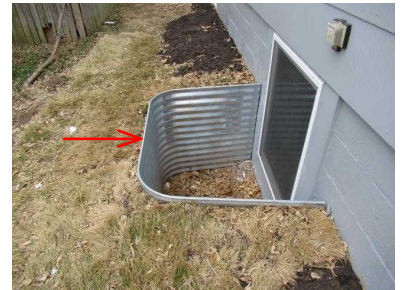
1. Window Wells: Not covered - Window well is not covered. Uncovered window wells can hold debris and moisture at the foundation wall. Recommend covers.

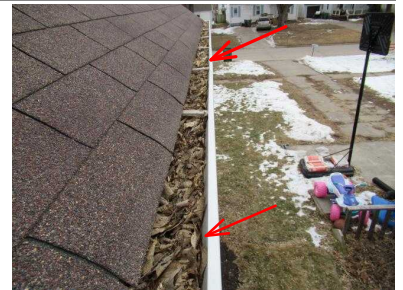
2. Gutters: Aluminum or metal - Gutters are full of debris. Recommend cleaning as part of regular maintenance.

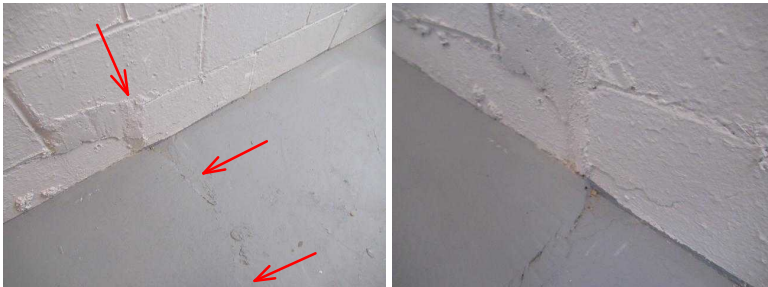
3. Foundation: Block - There is some settlement with displacement at the south block wall in the utility room and cracks at the concrete floor. I believe this is from previous water intrusion and probably is the reason for the recently added backfill along the south exterior wall. Recommend the buyer monitor this area and add additional backfill if needed.

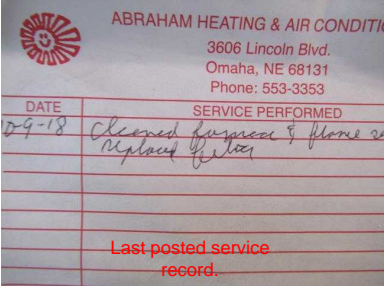
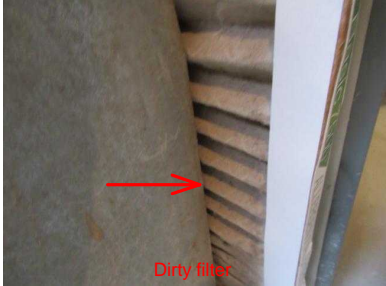
4. Basement Heating System Heating System Operation: Functioning - The furnace did not have current posted service records and has a dirty filter. Recommend a qualified HVAC company service, clean and evaluate the HVAC system.

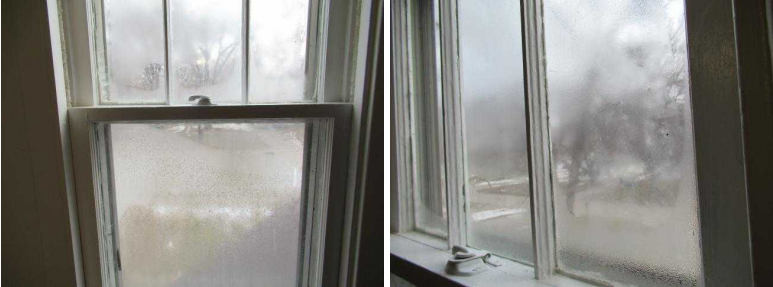
- 5. Living Room, Upper level Living Space Windows: Wood slider - Some of the older windows are not efficient and moisture/condensation is getting in between the window and the storm windows. Recommend sealing window gaps or changing out to newer windows at some point. This is an FYI.

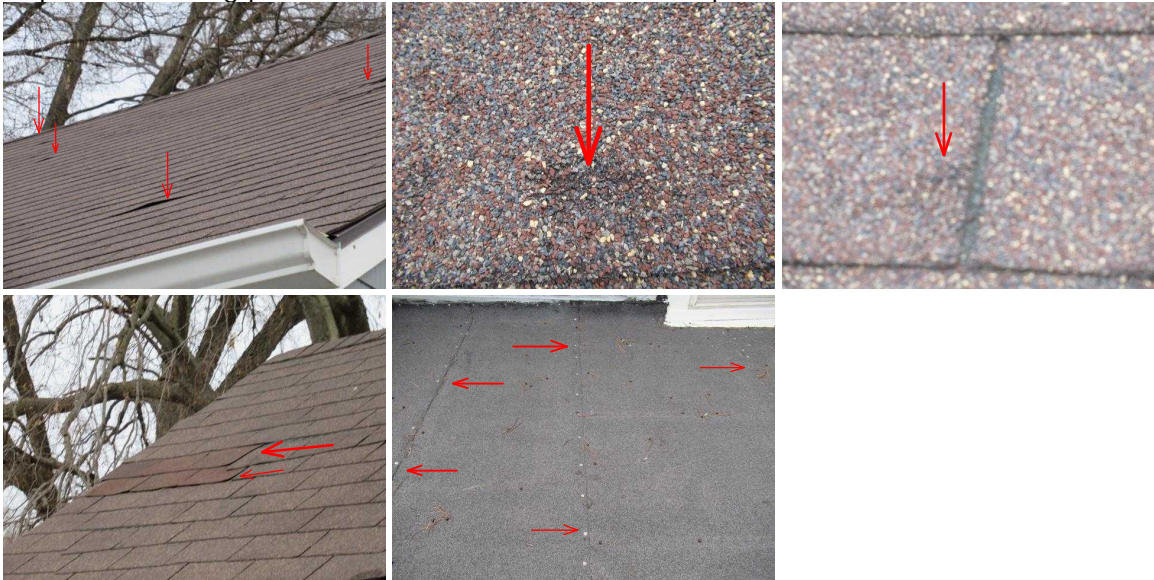
1. Main Roof Surface Material: Asphalt shingle, Rolled roof material - This is a gable roof with a flat roof over the added attached garage. The gable roof coverings have slight shingle lift with some hail strikes and previous repairs to the coverings. The flat rolled roofing material nail heads are exposed without a sealant. Recommend a qualified roofing professional evaluate further and repair as needed.

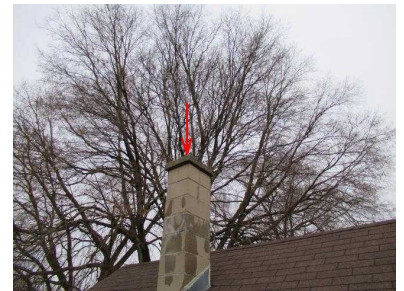
2. Center of the Home Chimney Flue/Flue Cap: Missing - Chimney cap is missing. Recommend installation. Recommend a qualified contractor evaluate further and repair as needed.

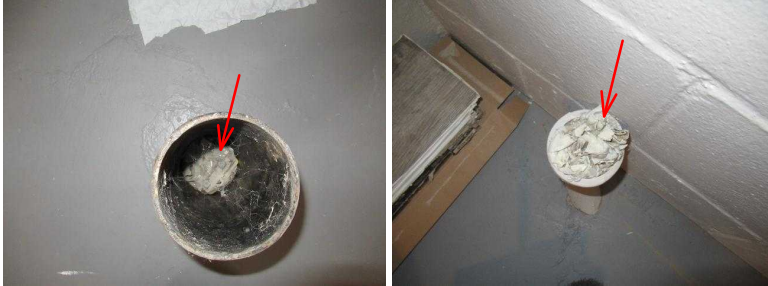
3. Drain Pipes: Cast iron - There is a rough-in for a toilet and sink in the basement north east corner. The waste lines have been filled with paper materials to block sewer gases from coming back into the home. I recommend that these lines are capped off the proper way to keep out sewer gases. Recommend a licensed plumber evaluate further and repair as needed.

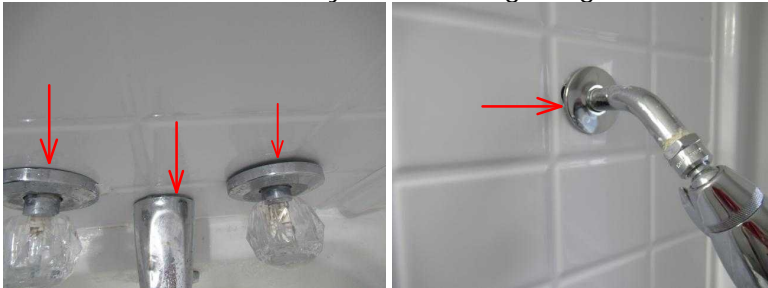
4. Main bathroom, Basement Bathroom Bathroom Faucets/Traps: PVC trap - There is noise at the main bathroom sink and tub line when draining. This may be a venting issue or partial plug. Recommend a licensed plumber evaluate further and repair as needed.
5. Main bathroom, Basement Bathroom Bathroom Tub/Surround: Fiberglass tub and fiberglass surround - Main bathroom showerhead, handles and tub spout have gaps at the front wall. Recommend sealing/caulking at these areas to control any water from getting behind the surround.

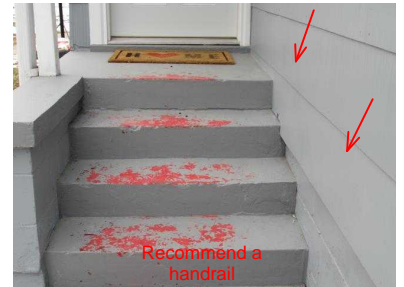
1. Steps/Stoops: Concrete - Missing handrail. This is a safety concern. Recommend a qualified contractor evaluate further and repair as needed.

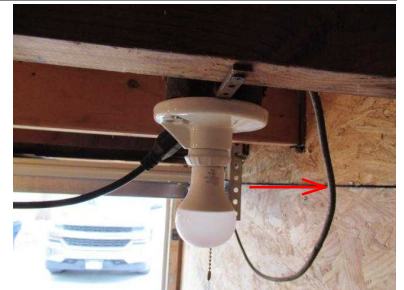
2. Attached Garage Electrical: 110 VAC - Exposed run of Romex for the light fixture. Recommend a licensed electrician evaluate further and repair as needed.
