Property Condition Report

123 Main St
Bellevue, NE 68005

Prepared for: Mary Smith

Prepared by: It's Your Home Inspection, LLC
9605 S 22nd Ave
Bellevue, NE 68147
402-885-1498
ASHI Member ID #261062

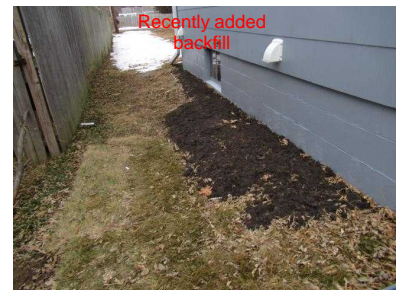
6. Window Wells: Not covered - Window well is not covered. Uncovered window wells can hold debris and moisture at the foundation wall. Recommend covers.
